# **ADVANTIS HOME INSPECTION, PLLC**

## PROPERTY INSPECTION REPORT

**Concerning:** 1-4 Your Street, Dallas/Fort Worth, TX 75000  
(Address or Other Identification of Inspected Property)

**By:** Dan J Fitzner, Lic #TREC #21610 12/01/2015  
(Name and License Number of Inspector) (Date)

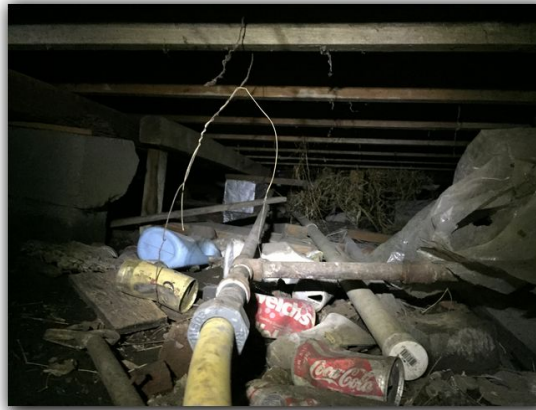
1. **Crawl space has debris in one or more sections under the house.** This debris allows rodents and other varmints to exist under structure. Debris should be removed and a clean environment maintained.

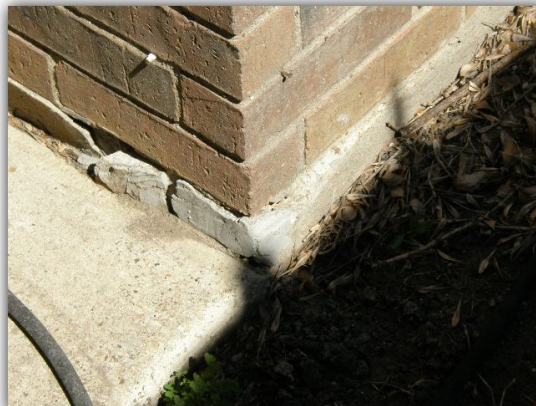
2. **One or more of the foundation perimeter beam corners were observed to be sheared off (corner pop).** This is a common condition in slab on grade foundations. This condition does not adversely affect the performance of the foundation. However, in some cases, some cosmetic improvements may be necessary.

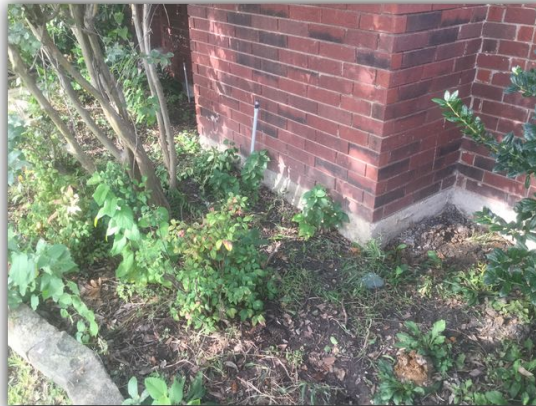
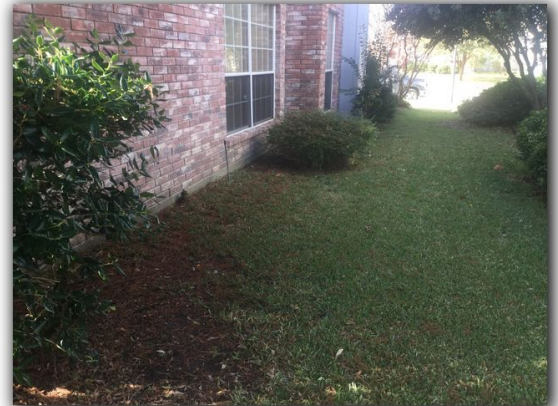
3. **The grading should be improved to direct storm/rain water away from the house.** This can usually be accomplished by the addition of top soil. The ground should slope away from the house at a rate of one inch per foot for a minimum of ten feet. Ideally, at least eight (6) inches of clearance should be maintained between soil level and the top of the foundation walls.

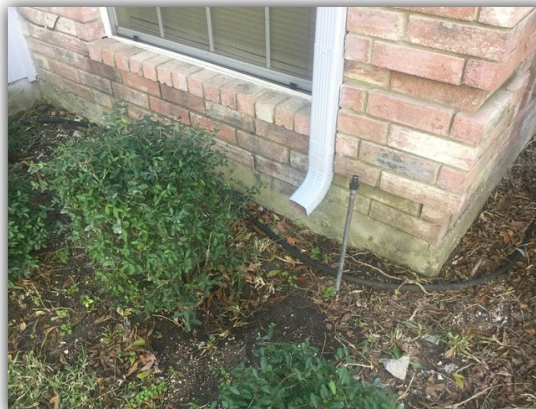
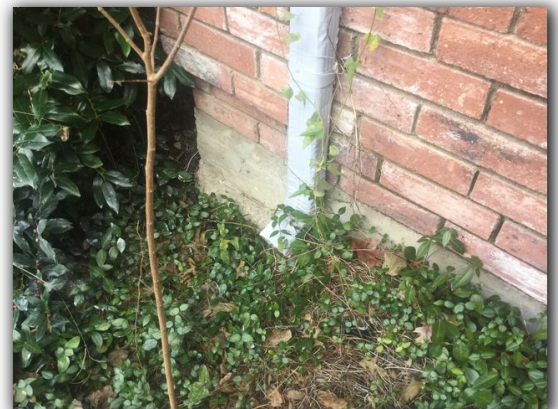
4. **One or more of the downspout extensions are too short.** The gutter downspout's should discharge water at least 3-feet to 5-feet away from the structure. Storm/rain water should be directed to flow away from the building at points of discharge.

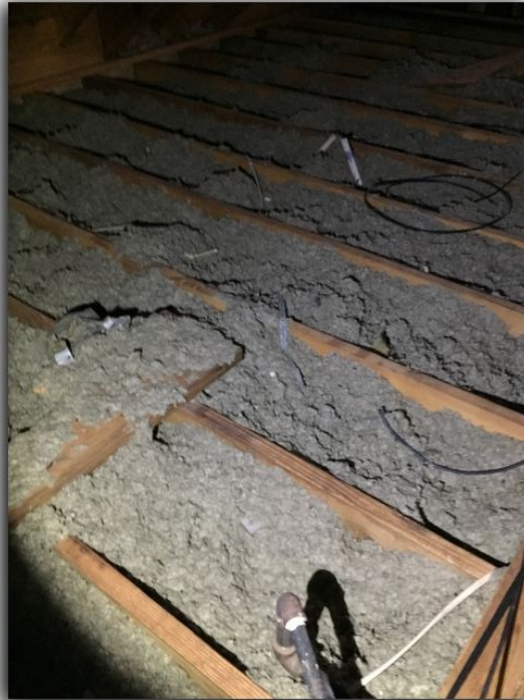
5. **Insulation in the attic appears to be about 2 to 7 inches deep of Rock wool - Loose fill .** The suggested depth for an "R" value of 30 is about 10 to 14 inches, depending on the type of insulation. This type of insulation gives an R-value of 2.9 per inch, which gives the current level of insulation an R-value of 5.8 to 20.3 Adding un-faced blankets of insulation or blown in (loose fill) insulation would be a good idea.

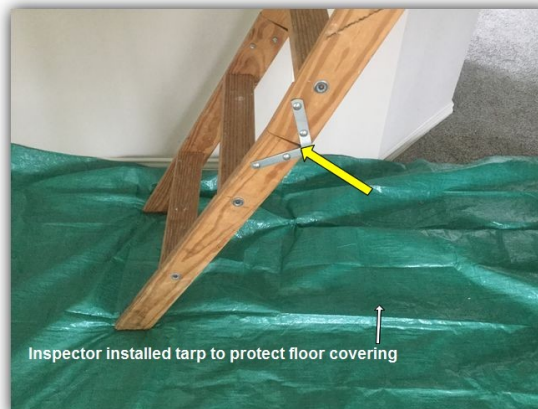
6. **The attic pull down ladder steps have been cut too long.** All sections of the ladder should be in line when fully extended. The lower section of steps should be trimmed so the hinge joint completely closes when in use. This situation puts undue stress on the hinge joint, and could fail when in use. This is a safety concern, and should be repaired as soon as possible.

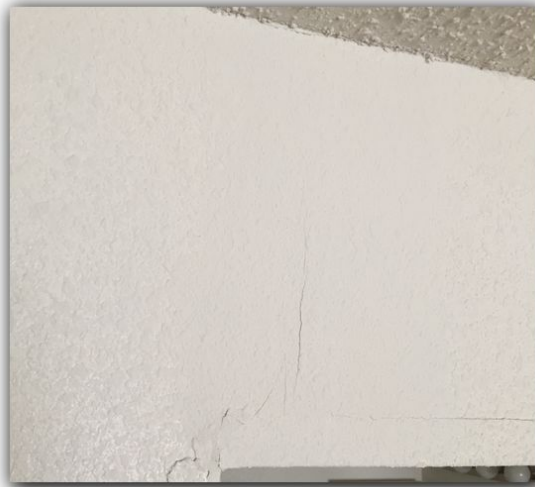
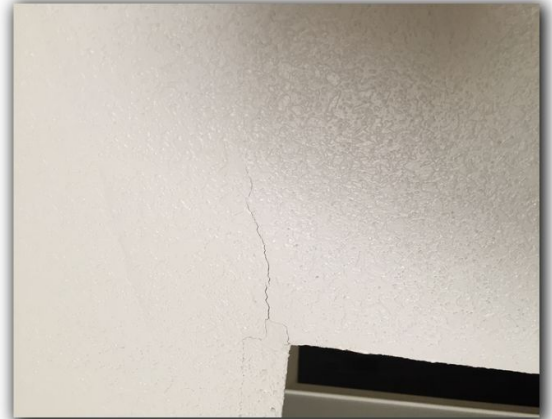
Interior Walls

**7. Common hairline cracks were noted in the interior gypsum wallboard, in one or more locations.**

Cracks near the interior windows and doors are usually indications that there is some degree of movement occurring in the structure. It is normal for any structure to have some degree of movement. This is typical for this area, and is not a big concern.

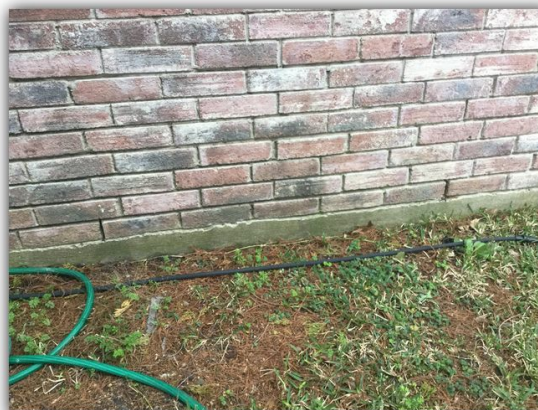
Exterior Walls

**8. There are not enough weep-holes in the lower course of masonry veneer, on the *West, East* side of the house.** Under current building standards, there should be weepholes in the lower course of the

masonry veneer, no more than 33" apart, to help drain water from the air space between the brick and wall framing.

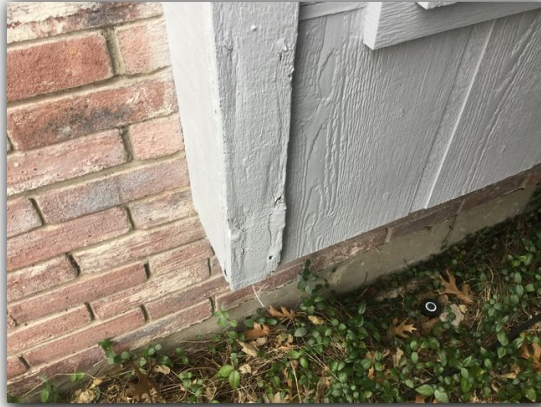
9. The exterior trim and/or siding has areas of soft/damaged, or decayed wood, at the Northeast side of the house. Recommend replacing all deteriorating/ damaged wood.

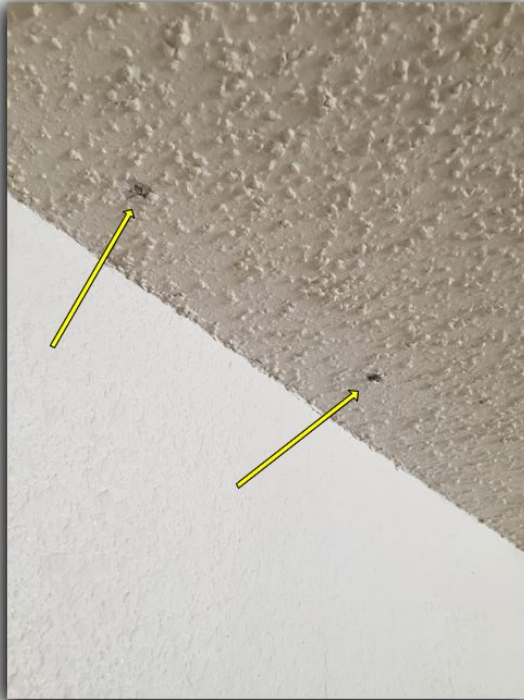
**Ceilings**

10. **There are "nail pops" on the ceilings and/or walls in one or more rooms of the house.** Nail pops are caused when the heads for sheet rock nails push through the interior finish . These are easily driven tight and patched.

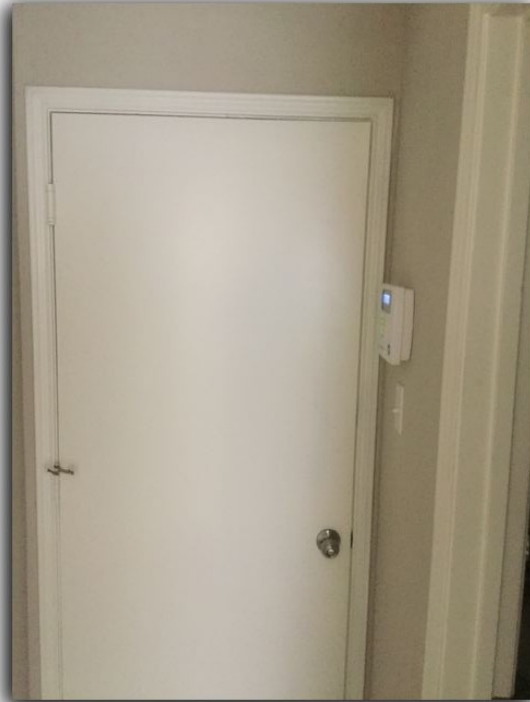
Interior Doors

11. There are one or more loose hinges on the door to the *Hall Closet*. This is a simple fix, they just need to be tightened, and the door will work properly.

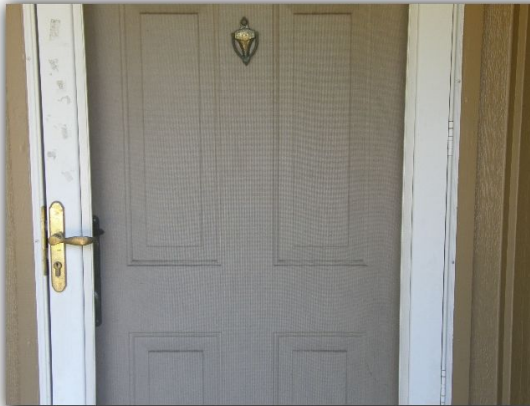
Exterior Doors

12. The screen for the Entry Foyer exterior door is damaged and should be repaired or replaced.

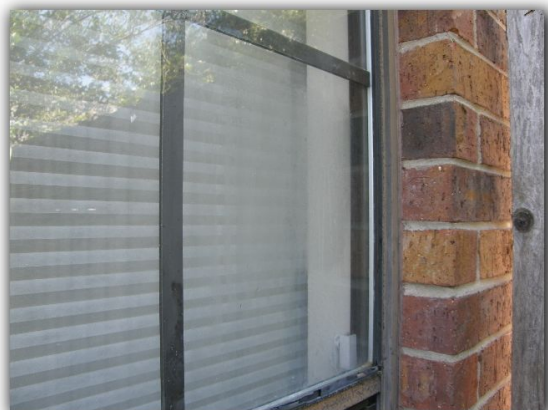
13. One or more of the thermal pane windows in the Master Bedroom, have lost their seals. This causes condensation or a fog like film to develop between the panes of glass. These windows loose their insulating properties and replacement may be necessary.

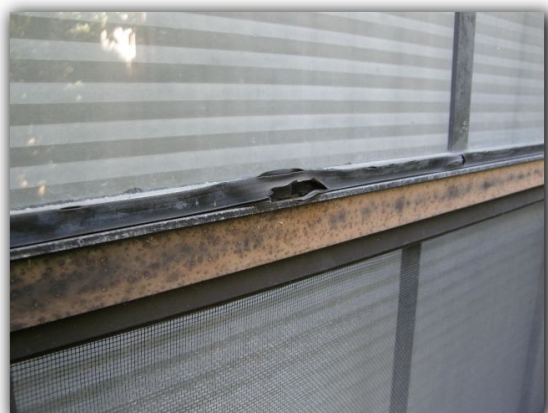
14. Exterior weather stripping on the Den windows has degraded or is ineffective. Loose or improperly secured glass panes are considered a recognized hazard. Proper weather stripping the windows will also make the house more energy efficient and quiet.

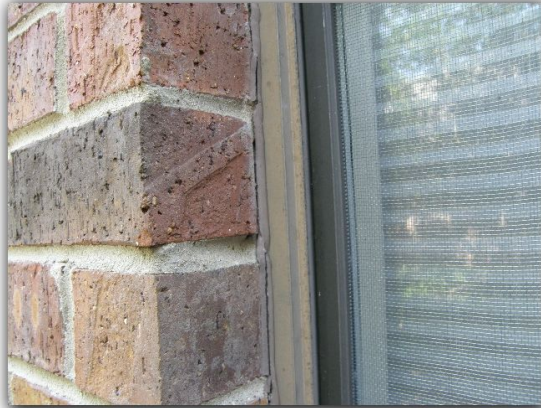
15. **The majority of windows need caulking repaired/replaced at the brick/ siding, or trim.** Repair of this seal will stop water infiltration, and possible damage to the structure and/or finishes. Recommend using an elastomeric caulk, available at most big box home stores.

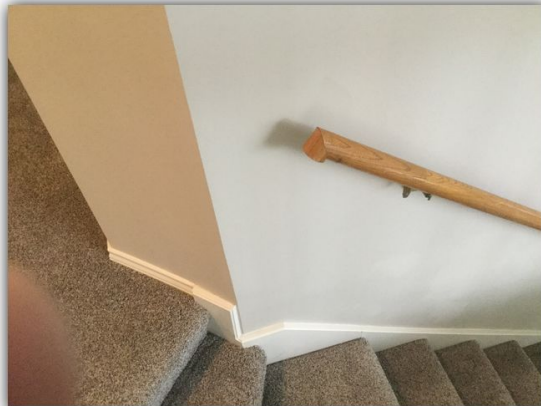
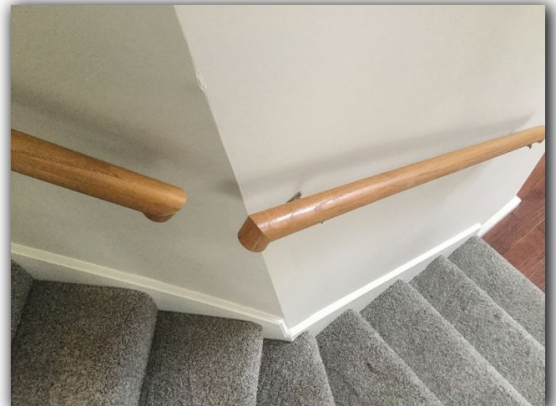
16. **The stairway handrail does not run continuous from the bottom of the stairwell to the top.** Under current building standards all handrails for a stairway should run continuous for the full length.. The handrail should start directly above the lowest step and run continuously to end directly above the top step. Recommend corrections to improve safety.

17. **The handrail ends are improperly terminated.** Current building standards require the ends of a handrail, must return to a wall, post, or safety terminal. Recommend repairs to improve safety.

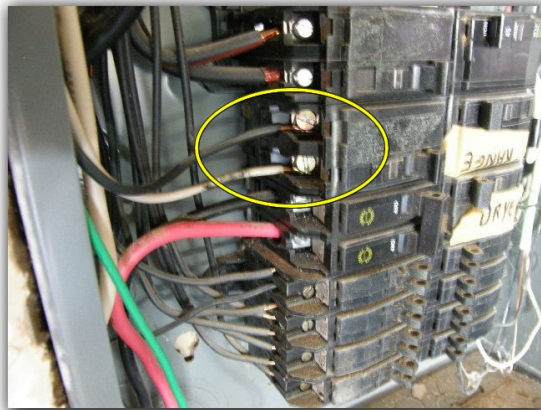
18. **There are one or more Black (hot) and/or White (neutral) wires incorrectly labeled.** Under current electrical standards; A Black (hot) wire used as a neutral must be labeled with white tape. A White (neutral) wire used as a hot, must be labeled with black tape. Recommend further evaluation by a qualified, licensed electrician, and repairs made as needed. *It appears there may have been black marking tape on this wire at one time, but was removed or has fallen off. It should be replaced.*

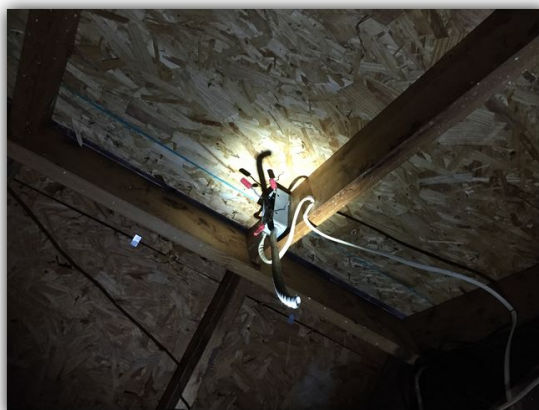
20. Improperly spliced and terminated electrical wires were observed in the attic area, located over the *Hallway*. Spliced wires in the attic should be properly enclosed in junction box(s) with appropriate covers, and secured to the rafter. This is a fire and safety hazard.

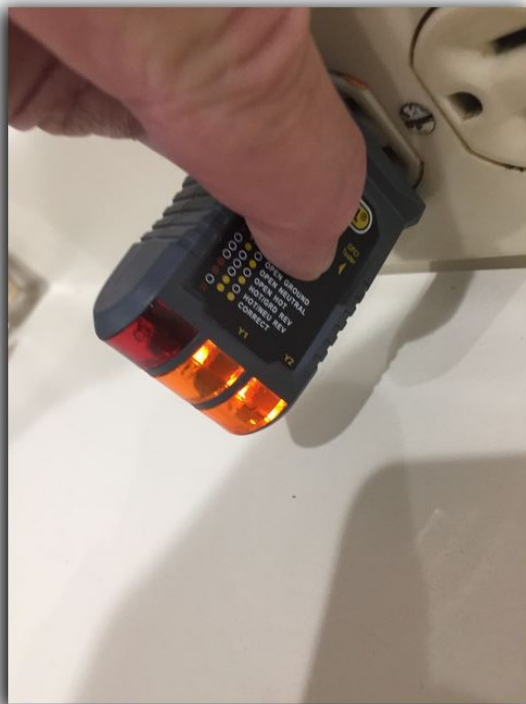
21. Not all of the kitchen counter top receptacles appear to be connected to a ground fault circuit interrupter (GFCI) device. When a GFCI tester was engaged, the circuit remained live. Under current electrical standards, all kitchen counter top receptacles should have GFCI protection. Recommend further

evaluation by a qualified, licensed electrician, and corrections made as needed.

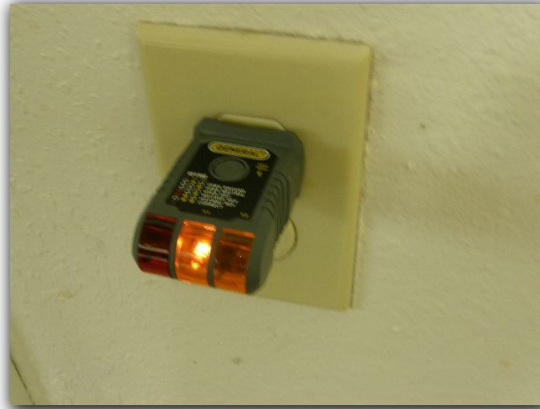
22. **One or more receptacles in the Office, appear to have an open ground connection.** This receptacle(s) and circuit should be further investigated by a qualified, licensed electrician, and repaired as needed.

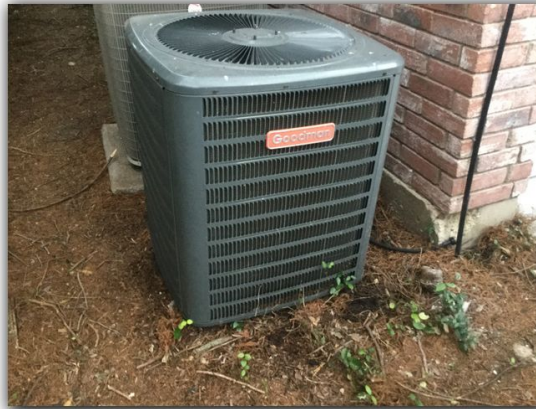
23. **The Heat Pump outside condenser/coil does not appear to have proper clearance above the finish grade** (ground). The outside unit should have a minimum of 3-inches of clearance above finish grade (ground). This condition should be corrected to help prevent damage to the unit.

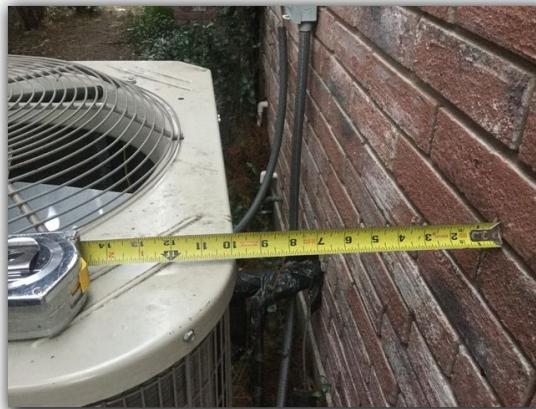
24. **The outside condenser/coil is set too close to the house.** Current standards recommend a minimum of 12" to allow sufficient air flow and efficient operation.

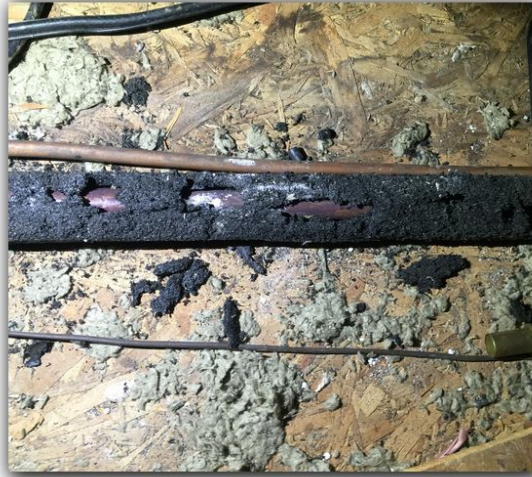
**Damaged, deteriorated and/or missing insulation on the refrigerant lines in the attic area should be repaired or replaced as necessary.**

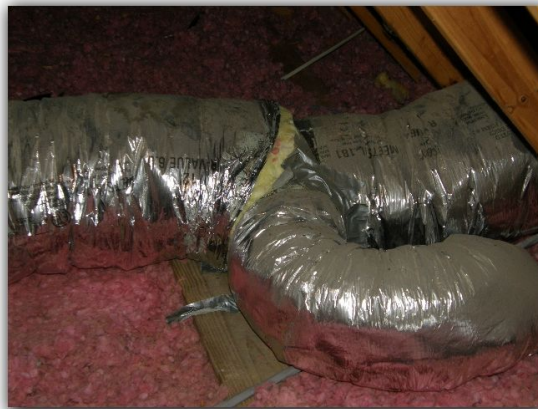
25. **Loose fitting joints and/or openings in the ductwork should be sealed.** This item should be repaired to increase the efficiency of the system. Repairs are fairly easy, and approved supplies/materials are available at most big box home stores.

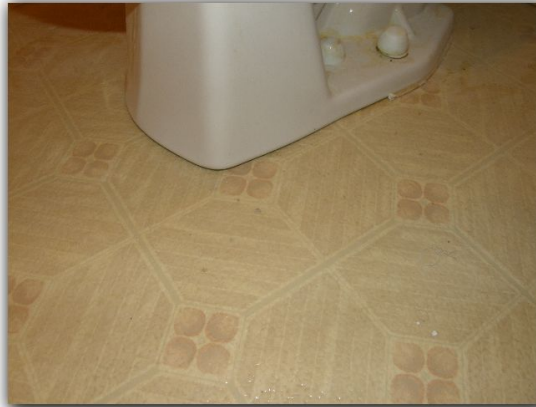
27. **The commode is not sealed to the floor.** Under current building standards the commode/toilet should be caulked to the floor around the perimeter of the base. This condition should be corrected..

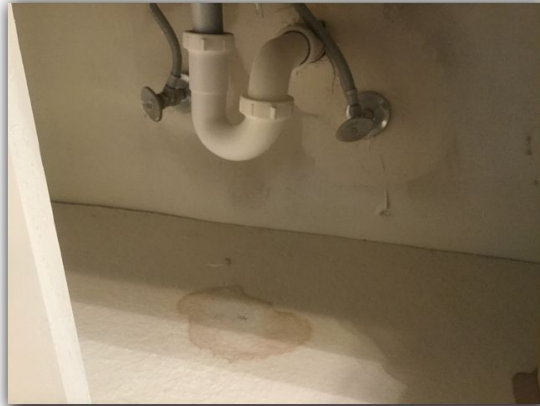
28. **There is a leak in the P- trap under the Guest Bath sink.** These leaks can allow water penetration to the surfaces and/or structure. Concealed damage is a possibility. The P-trap should be serviced and any damaged components replaced or repaired.

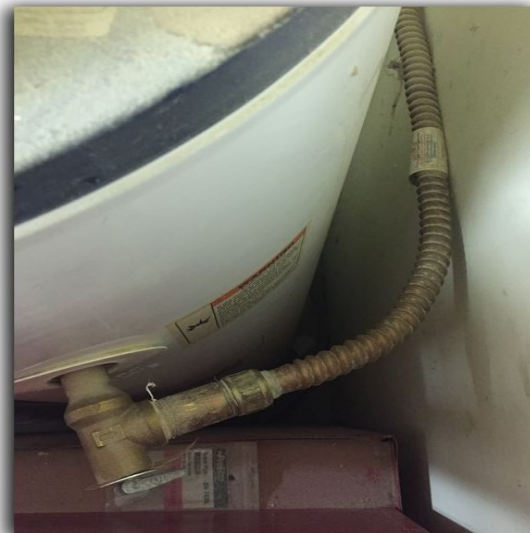
29. **The discharge pipe for the temperature and pressure relief (T&PR) valve has been downsized.** Current building standards require the discharge pipe to be the same size as the outlet of the valve, and cannot be reduced at any point, have any kinks or restrictions in the pipe, or have a threaded end. ( Note: a flex line is considered a reduction in size). Recommend repair by a qualified, licensed plumber.

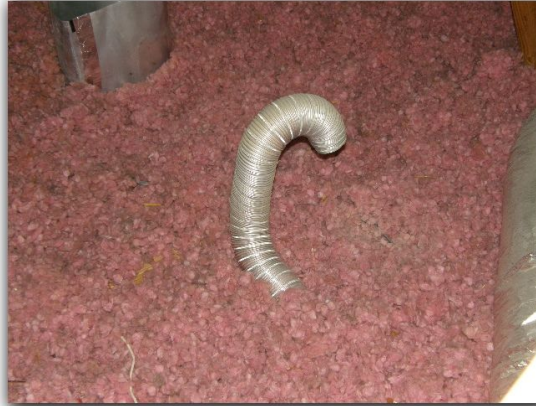
**30. The bathroom exhaust fan should be repaired so as to discharge to the building exterior.**

Discharging exhaust air from a bathroom can increase the moisture level in the attic and can lead to structure damage and/or mold growth. This should be corrected
