# **ADVANTIS HOME INSPECTION, PLLC**

## PROPERTY INSPECTION REPORT

**Concerning:** 1-4 Your Street, Dallas/Fort Worth, TX 75000  
(Address or Other Identification of Inspected Property)

**By:** Dan J Fitzner, Lic #TREC #21610 12/01/2015  
(Name and License Number of Inspector) (Date)

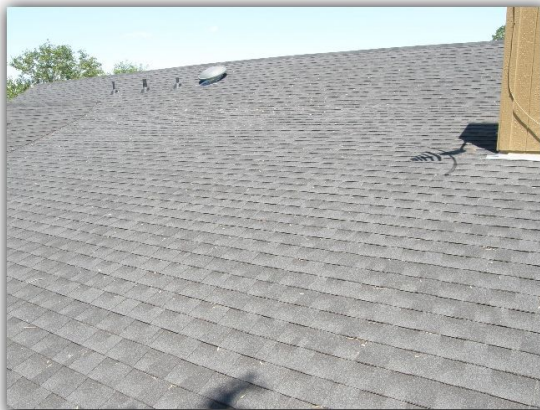
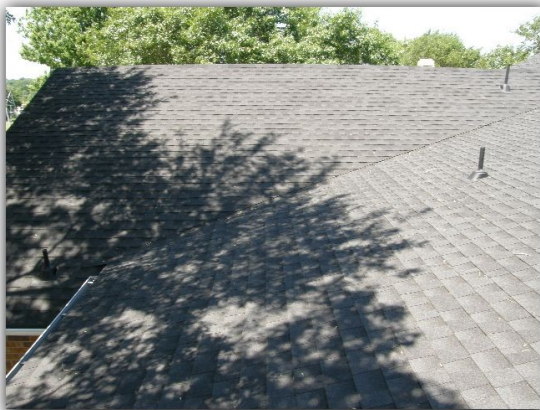
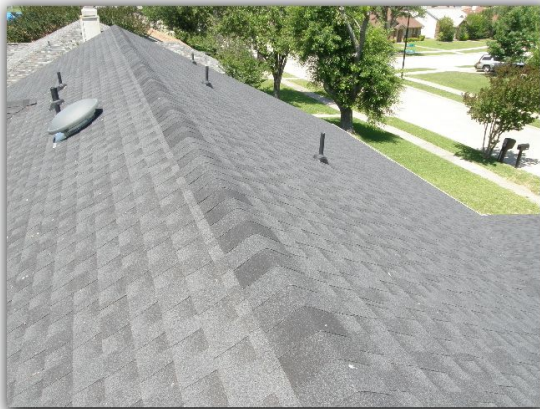
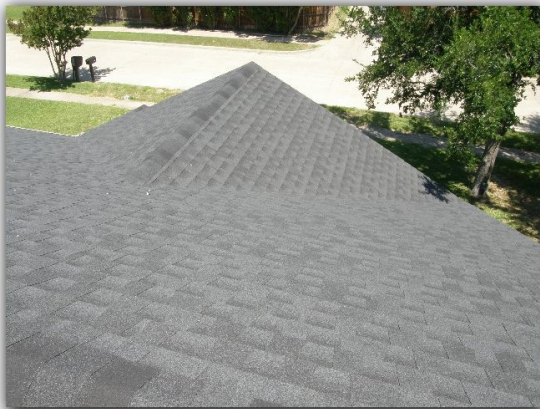
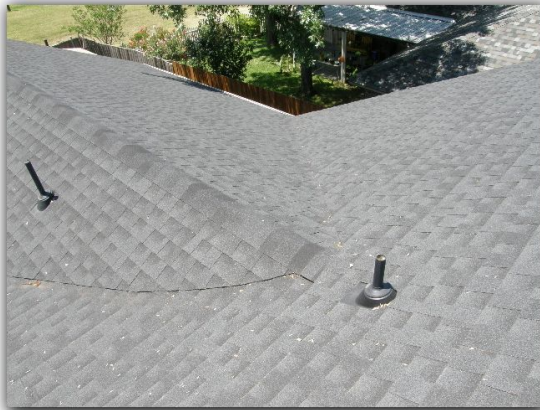
**The roof appears to be in the first 3rd of its useful life.**

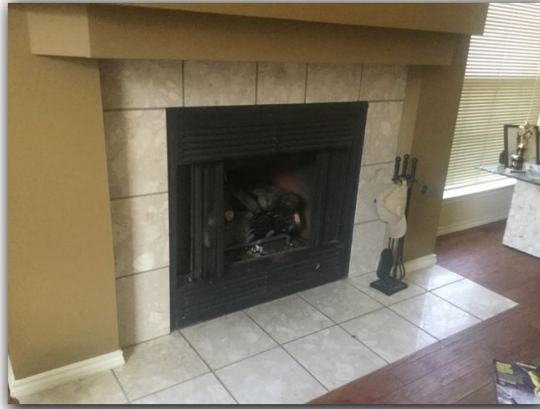
**J. Fireplaces and Chimneys**

**All components were found to be in satisfactory condition, I did not observe any indication of defects on the day of the inspection.**

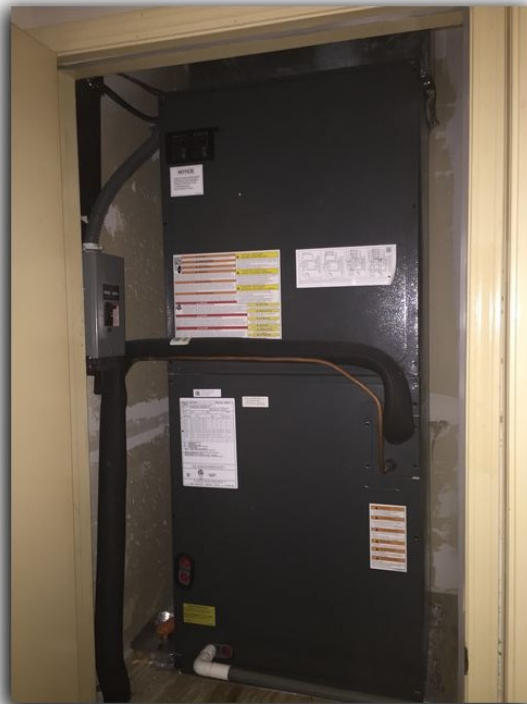
**This component appears to be performing adequately at the time of this inspection.** It is achieving an

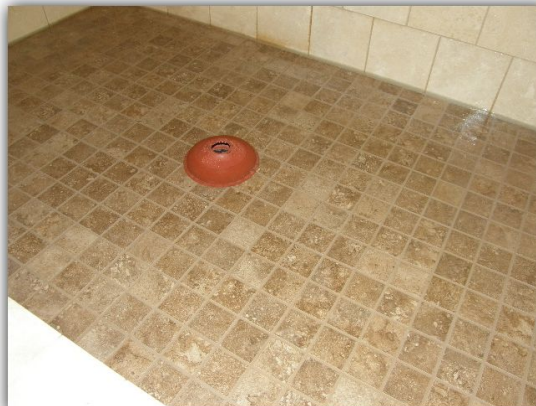
**The shower pan was tested by filling it with 2 inches of water and inspecting for leaks around the exterior walls of the shower pan.** I did not observe any indications of leaks at the time of this inspection.

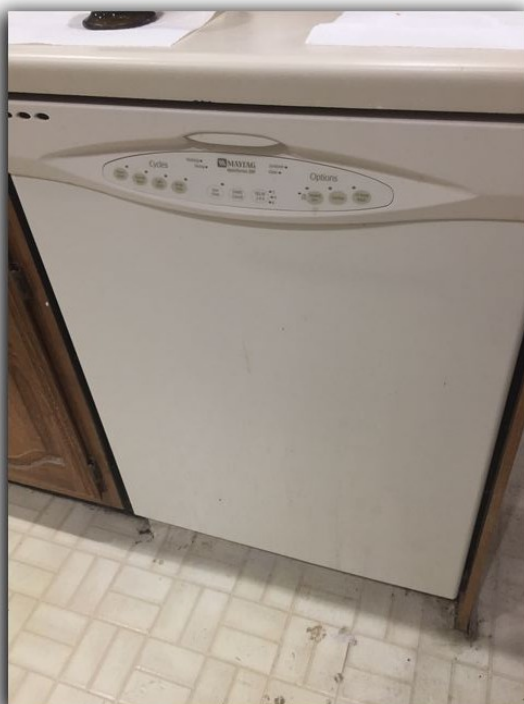
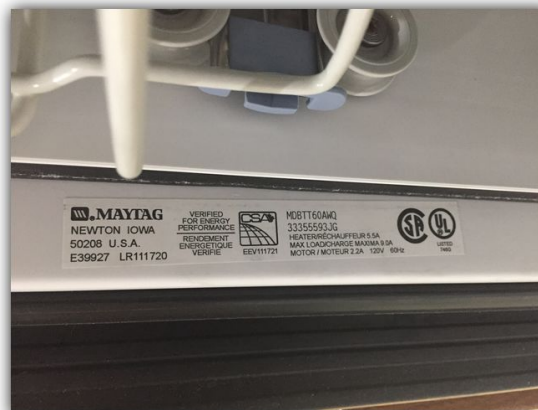
**A. Dishwashers**

**This component appears to be performing adequately**, I did not observe any indication of defects at the time of this inspection. It is achieving an operation, function, or configuration consistent with accepted industry practices for its age.

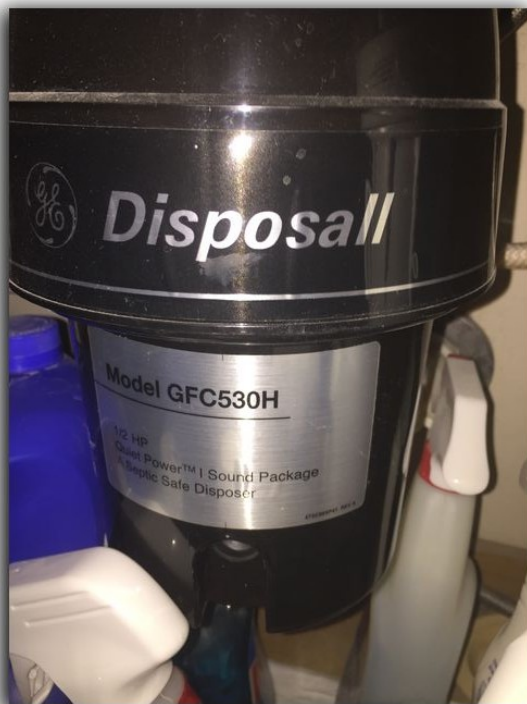
**B. Food Waste Disposers**

This component appears to be performing adequately, I did not observe any indication of defects at the time of this inspection. It is achieving an operation, function, or configuration consistent with accepted industry practices for its age.

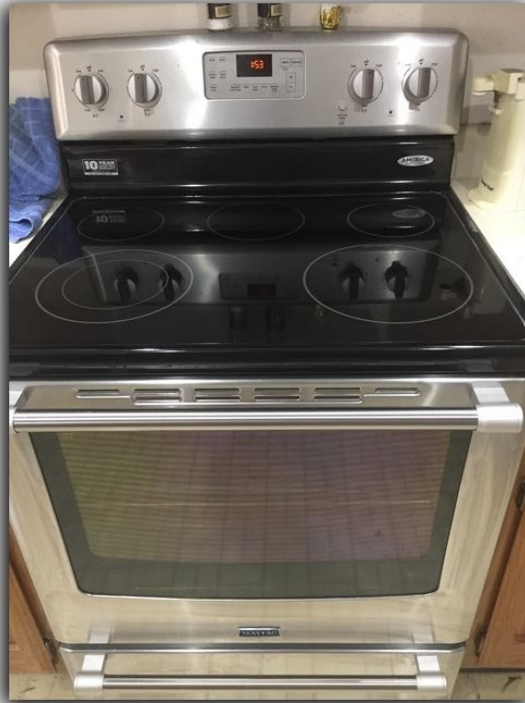
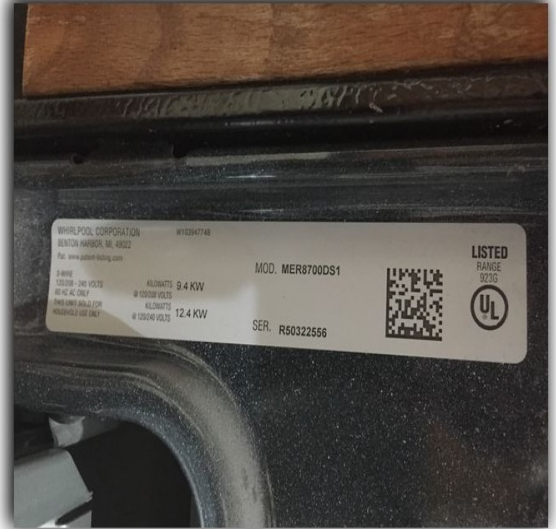
**D. Ranges, Cooktops, and Ovens**

**This component appears to be performing adequately. I did not observe any indication of defects at the time of this inspection.** It is achieving an operation, function, or configuration consistent with accepted industry practices for its age.

**The temperature of the oven was checked at 350 degrees.** The temperature rose to 345 degrees and held that temperature. A variance of plus or minus 25 degrees is consider acceptable.

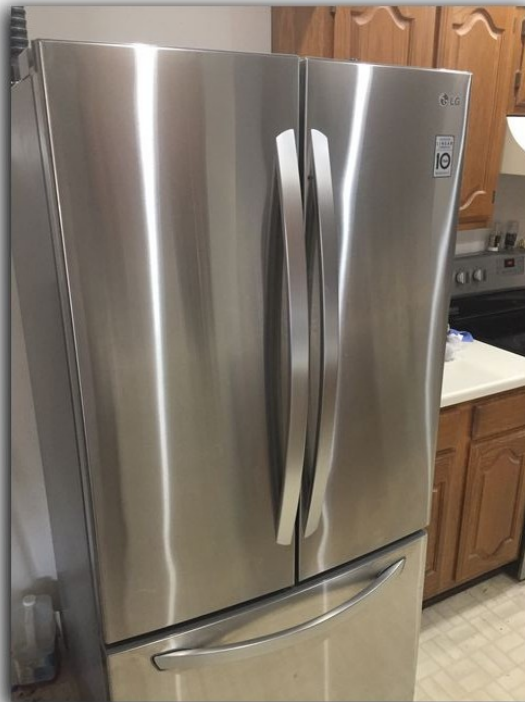
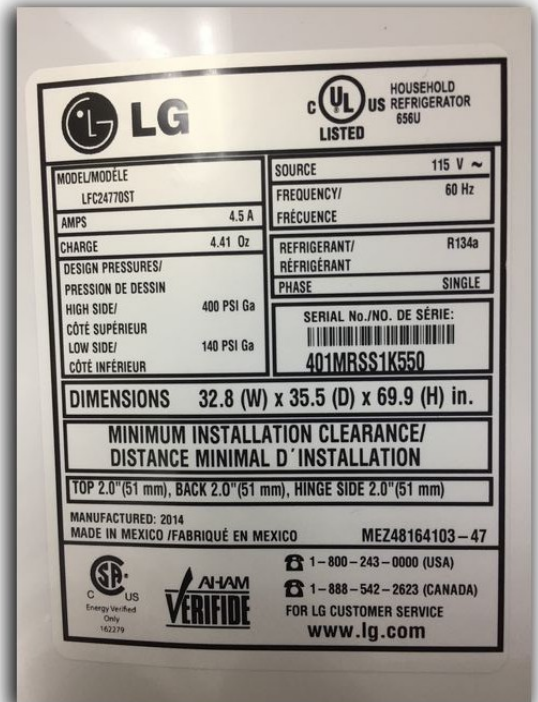
**I. Other**

**This component appears to be performing adequately, I did not observe any indication of defects at the time of this inspection.** It is achieving an operation, function, or configuration consistent with accepted industry practices for its age.
